**ALUCOBOND®**

Why to use ALUCOBOND®?

## ALUCOBOND Aluminium Composite Panels – A Successful Story

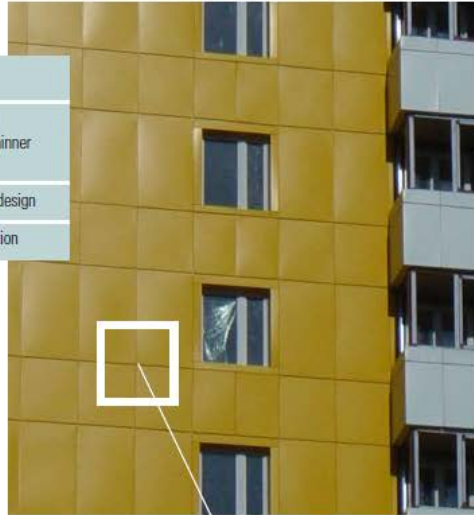
- 1 Insufficient panel strength due to thinner aluminium skins
- 2 Incorrect system design
- 3 Improper installation

When factors such as support structure, panel size and wind or heat loss are similar, the susceptibility to material sag and warp is higher and more visible in many products which claim to be "equivalent" to ALUCOBOND®

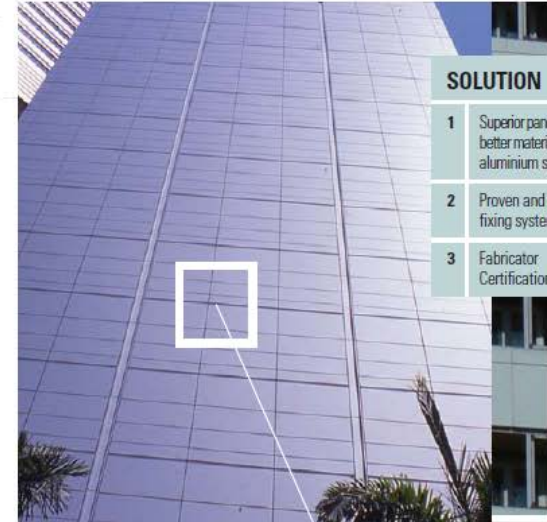
- 1 Superior panel strength due to better material composition & aluminium skins thickness
- 2 Proven and patented\* fixing systems
- 3 Fabricator Certification Programme

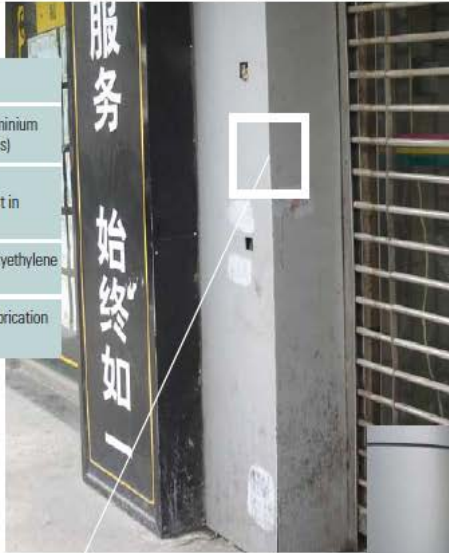
- 1 Use of inferior aluminium alloy (eg 1xxx series)
- 2 Inconsistent panel thickness can result in weaker panels
- 3 Use of recycled polyethylene core materials
- 4 Use of incorrect fabrication equipment

1xxx series aluminium alloy is an inferior metal commonly used in cooking pots and pans. Its lack of tensile strength may result in pressure cracks and dents when used in composite panels.

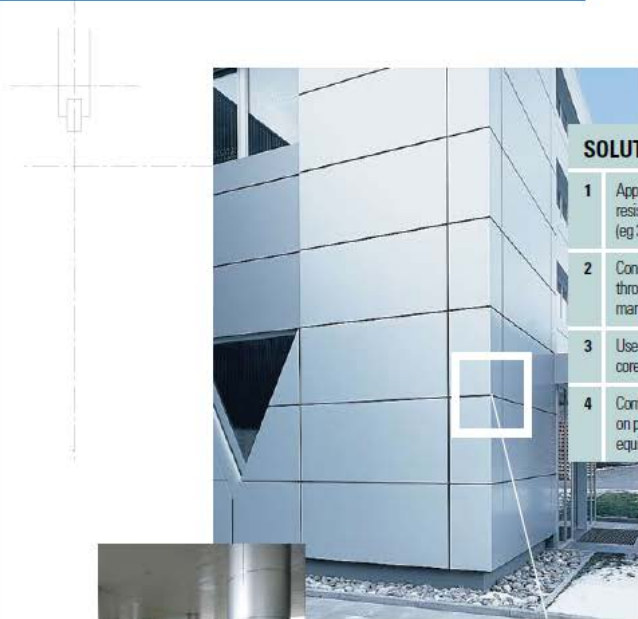
- 1 Appropriate use of corrosion resistant aluminium alloy (eg 3xxx series)
- 2 Consistent product quality through state of the art manufacturing processes
- 3 Use of virgin polyethylene core materials
- 4 Complementary consultancy on proper fabrication equipment & techniques

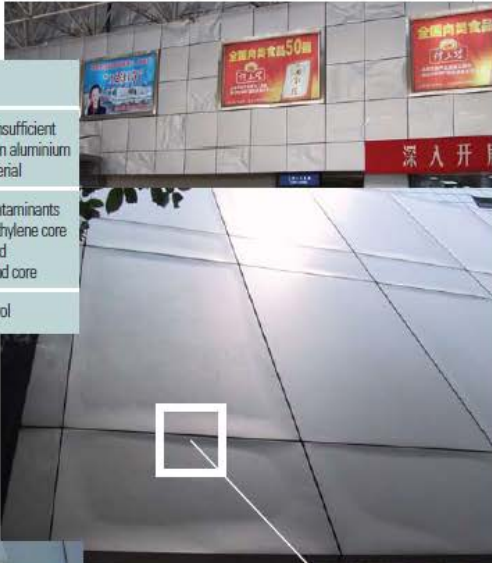
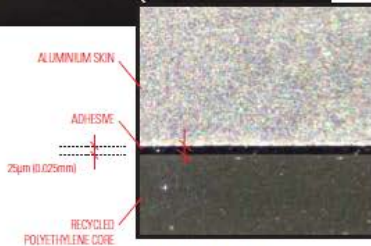
- 1 Inferior and / or insufficient adhesive between aluminium skins & core material
- 2 "Bleeding" of contaminants in recycled polyethylene core breaks down bond between skins and core
- 3 Poor quality control

MICROSCOPIC PICTURE

BRAND: A1  
TESTED BY: MAEK CONSULTANT PTE LTD  
DATE: 14 NOVEMBER 2008

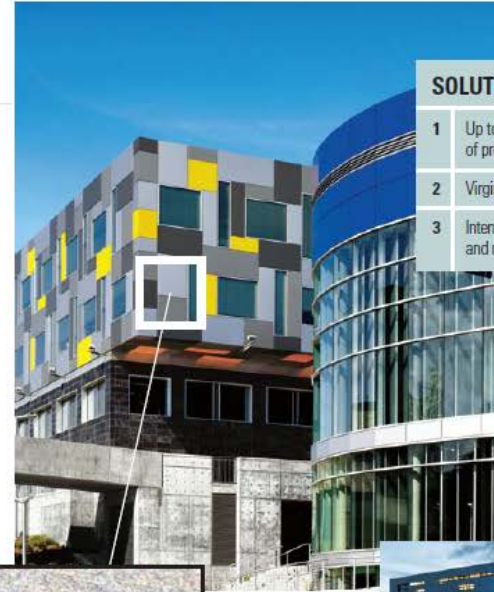
- 1 Up to 3 times thicker layer of premium adhesive
- 2 Virgin polyethylene core
- 3 International quality standards and manufacturing control

MICROSCOPIC PICTURE

BRAND: ALUCOBOND  
TESTED BY: MAEK CONSULTANT PTE LTD  
DATE: 14 NOVEMBER 2008

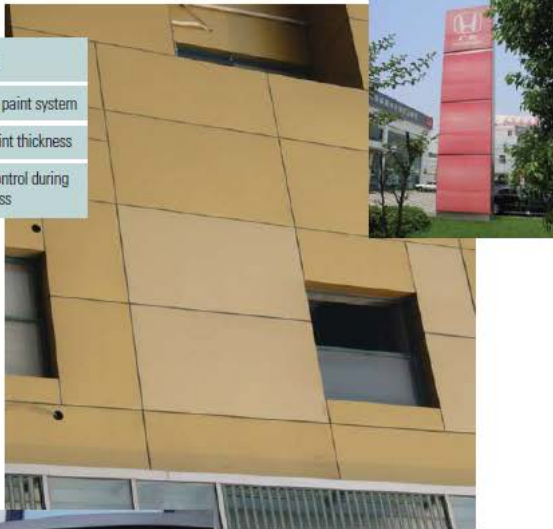
- 1 Use of inferior paint system
- 2 Insufficient paint thickness
- 3 Poor quality control during painting process

### WEATHERING TEST RESULT PAINT QUALITY OF INFERIOR ALUMINIUM COMPOSITE PANEL

FLORIDA EXPOSURE: 45 SOUTH, EXPOSED SINCE 1987

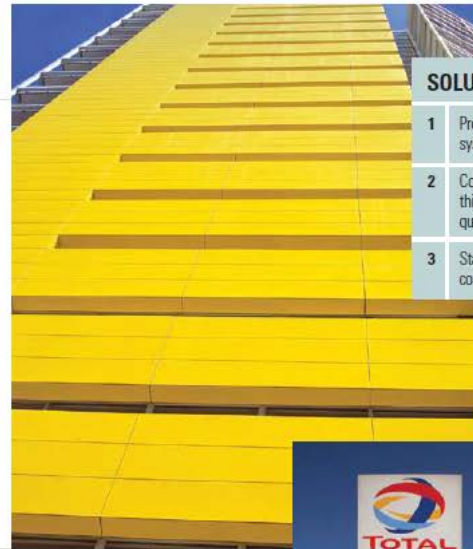
- 1 Proven quality of paint systems since 1969
- 2 Consistent coating thickness through stringent quality control
- 3 State of the art in-house coil coating facilities

### WEATHERING TEST RESULT ALUCOBOND QUALITY

FLORIDA EXPOSURE: 45 SOUTH, EXPOSED SINCE 1987

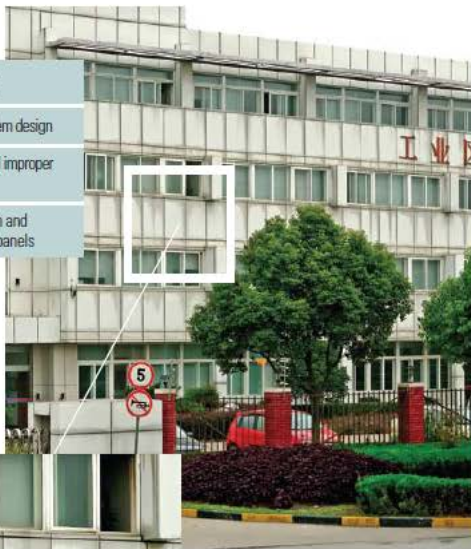
- 1 Poor fixing system design
- 2 Poor quality and improper use of sealant
- 3 Poor fabrication and installation of panels

BUILDING CLEANED REGULARLY BUT STAINING CANNOT BE REMOVED

Poor application and quality of facade products can lead to unsightly stains and fungal growth.

FUNGAL GROWTH DUE TO IMPROPER SEALANT USE

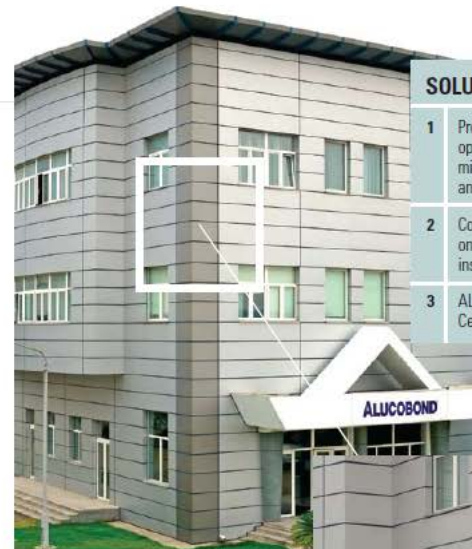
- 1 Proven and patented\* open joint system design minimizes streaking and staining
- 2 Complementary consultancy on proper fabrication and installation techniques
- 3 ALUCOBOND® Fabricator Certification Programme

TEN YEAR OLD FAÇADE OF ALUCOBOND® OFFICES WITH A PROVEN SYSTEM

PROVEN AND PATENTED\* OPEN JOINT FIXING SYSTEM

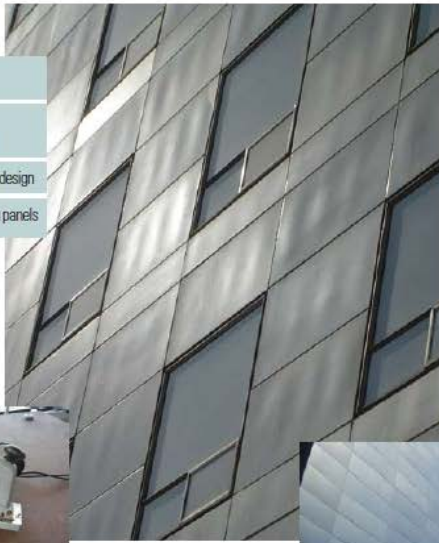
- 1 Poor fabrication & installation techniques
- 2 Incorrect fixing system design
- 3 Use of inferior cladding panels

MANUAL FABRICATION OF PANELS USING LOW SKILLED LABOUR, INFERIOR EQUIPMENT AND TECHNIQUES.

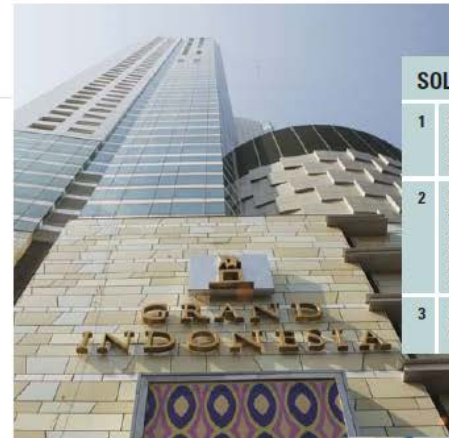
- 1 Complementary consultancy on proper fabrication and installation techniques
- 2 Proven and patented\* fixing system design. Supply of pre-routed panels using in-house state of the art manufacturing equipment
- 3 High quality cladding materials proven since 1969

SUPPLY OF IN-HOUSE  
PRE-ROUTED PANELS

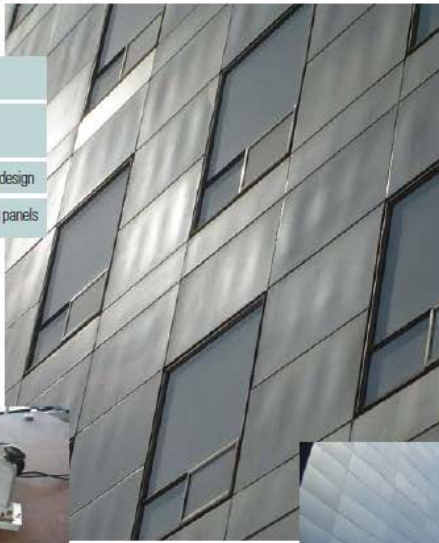
- 1 Poor fabrication & installation techniques
- 2 Incorrect fixing system design
- 3 Use of inferior cladding panels

MANUAL FABRICATION OF PANELS USING LOW SKILLED LABOUR, INFERIOR EQUIPMENT AND TECHNIQUES.

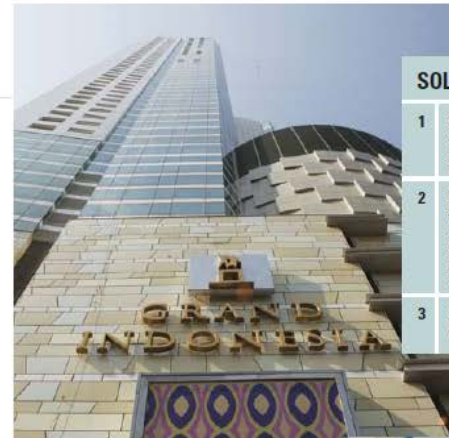
- 1 Complementary consultancy on proper fabrication and installation techniques
- 2 Proven and patented\* fixing system design. Supply of pre-routed panels using in-house state of the art manufacturing equipment
- 3 High quality cladding materials proven since 1969

SUPPLY OF IN-HOUSE  
PRE-ROUTED PANELS
